BEDFORD FIRE HEADQUARTERS BUILDING SPACE UTILIZATION ASSESSMENT STUDY

*A Report to: Town of Bedford
December 7, 2015*

Prepared by: **CDR Maguire Inc.**
2 Granite Avenue, Suite 150
Milton, MA 02186

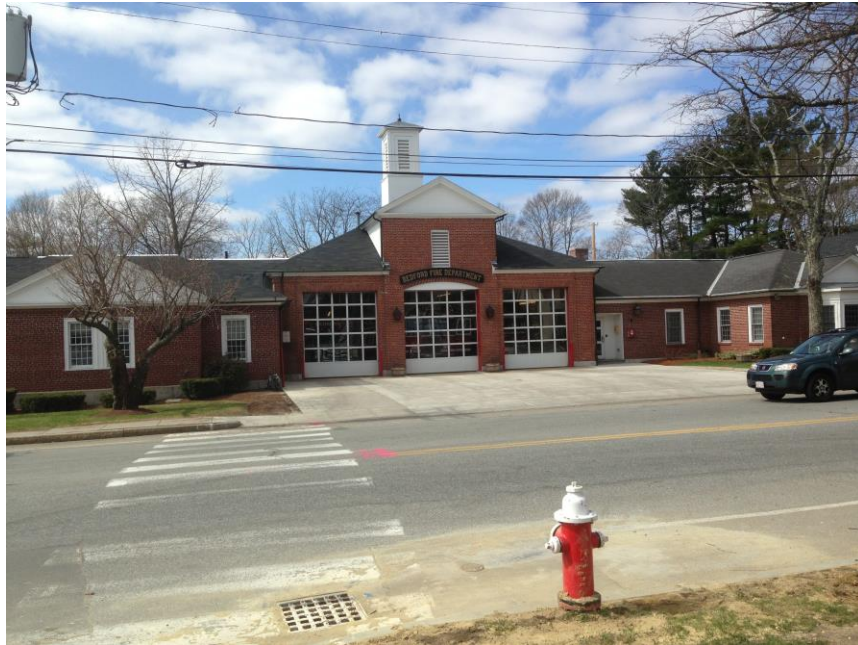
The front apron of the facility is too short to accommodate their ladder truck. Consequently, when parked outside, the front of the vehicle not only extends past the sidewalk but the front bumper overhangs onto Great Road. This causes not only a pedestrian safety issue, but a concern for the firefighters that need to walk around the front of the vehicle to access the sides.

Figure 1 – Front of facility with limited front apron

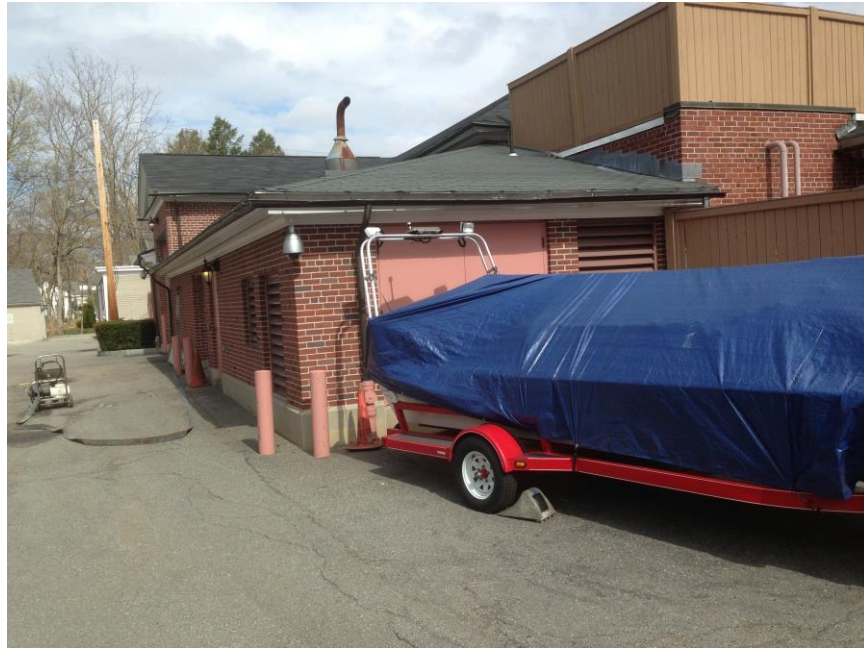
Figure 3 – Rescue boat occupying parking and blocking access to the emergency generator room

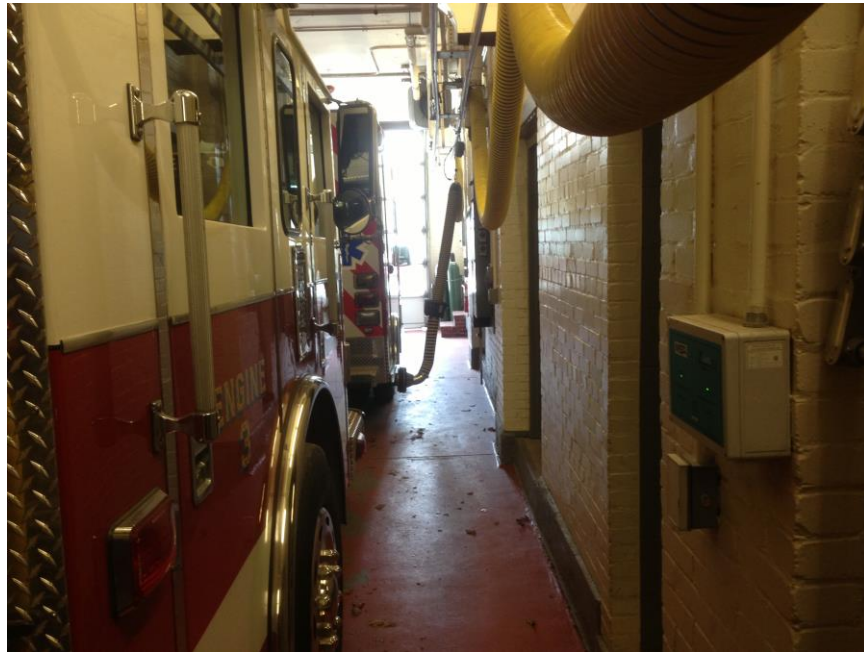
Figure 5 – Lack of space between fire apparatus and wall

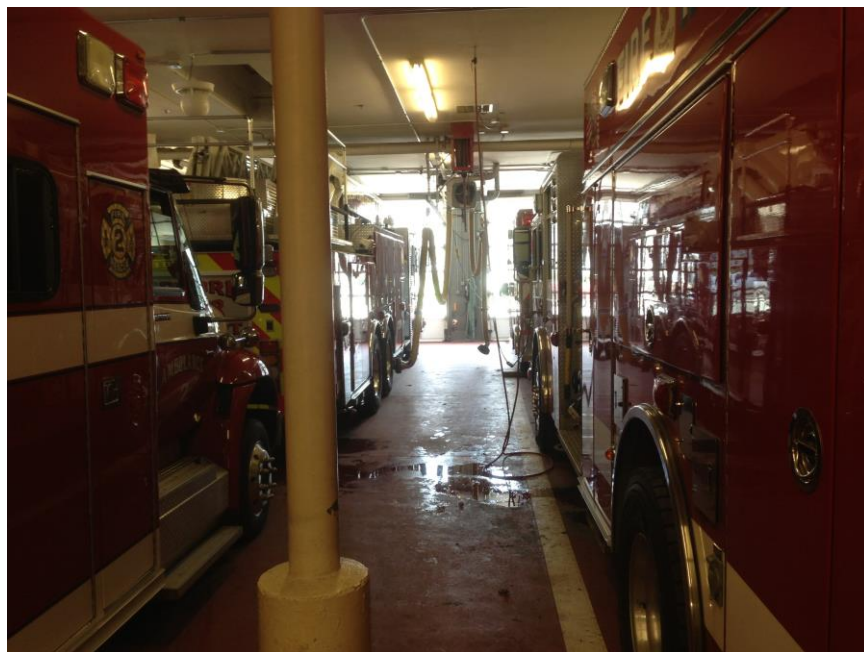
Figure 6 – Lack of space between apparatus and improperly pitched slab

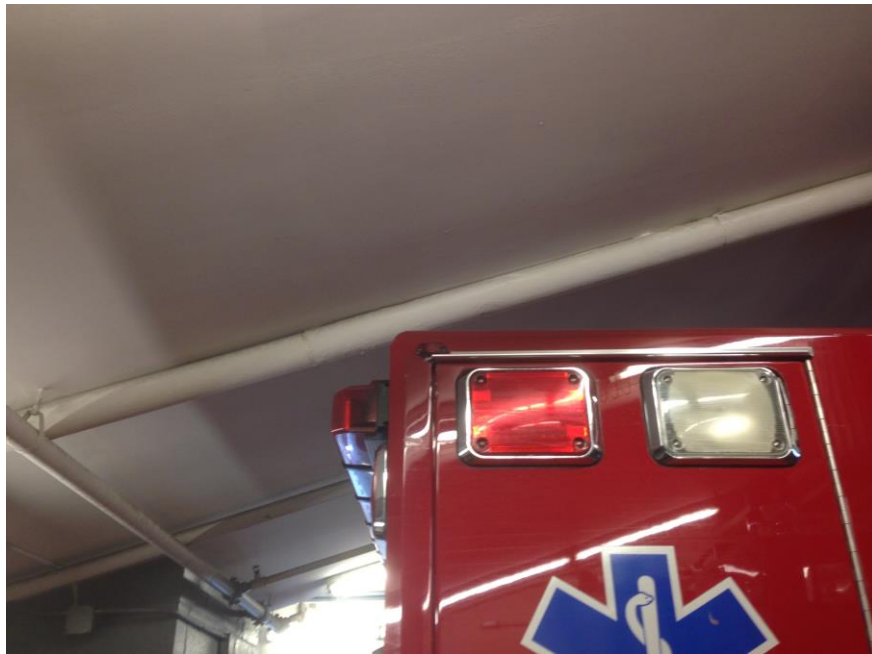
Figure 7 – Low ceiling clearances at ambulance

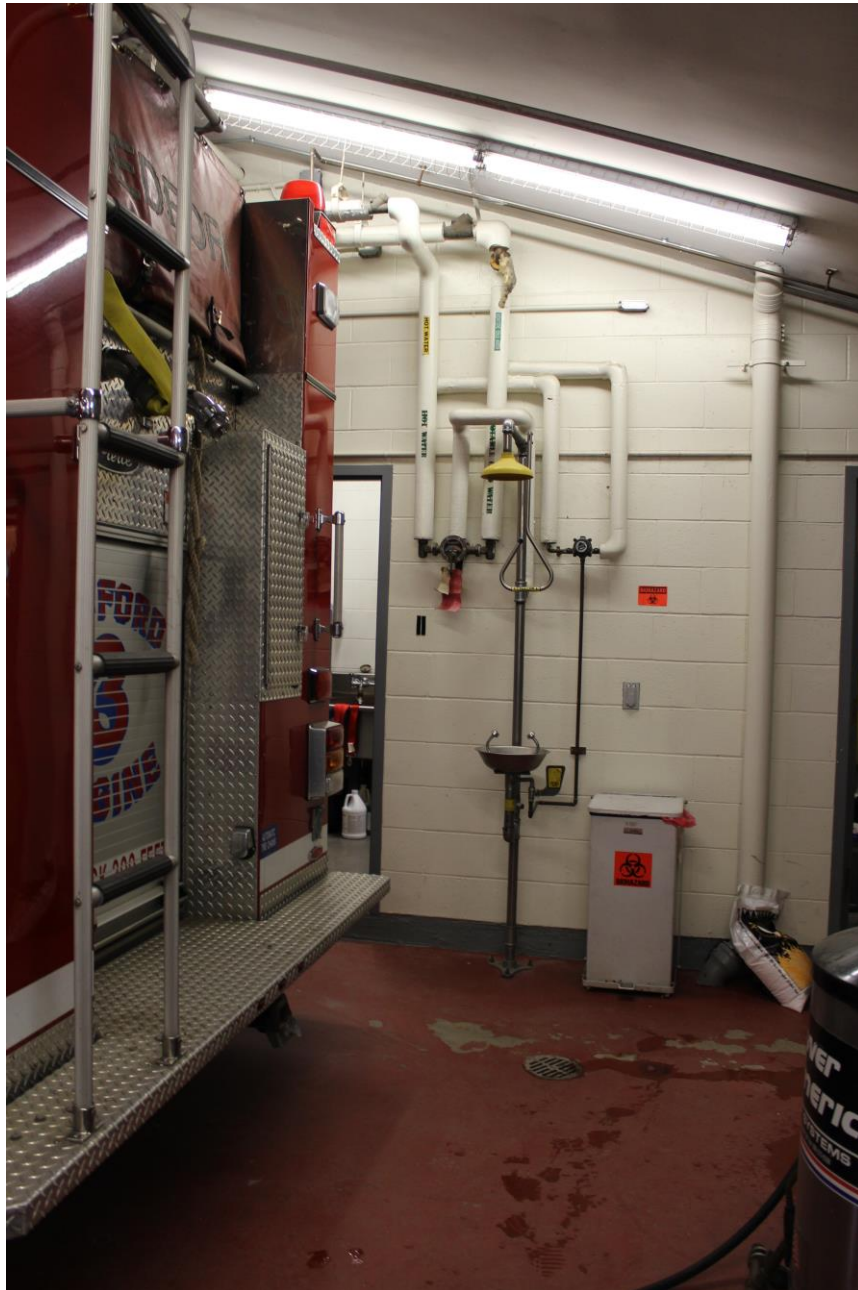
Figure 8 – Low ceiling clearances at Engine. Also emergency shower protrudes into walkway corridor

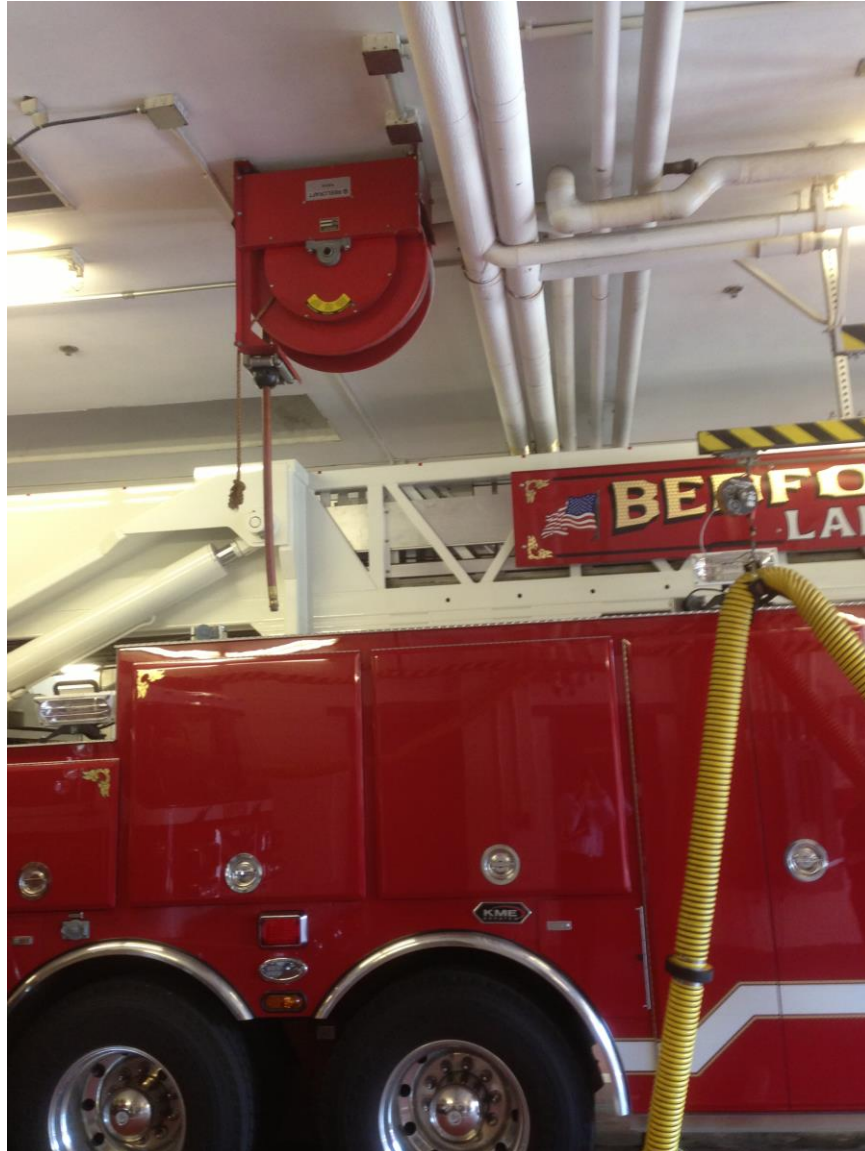
Figure 9 – Low ceiling clearances at ladder truck

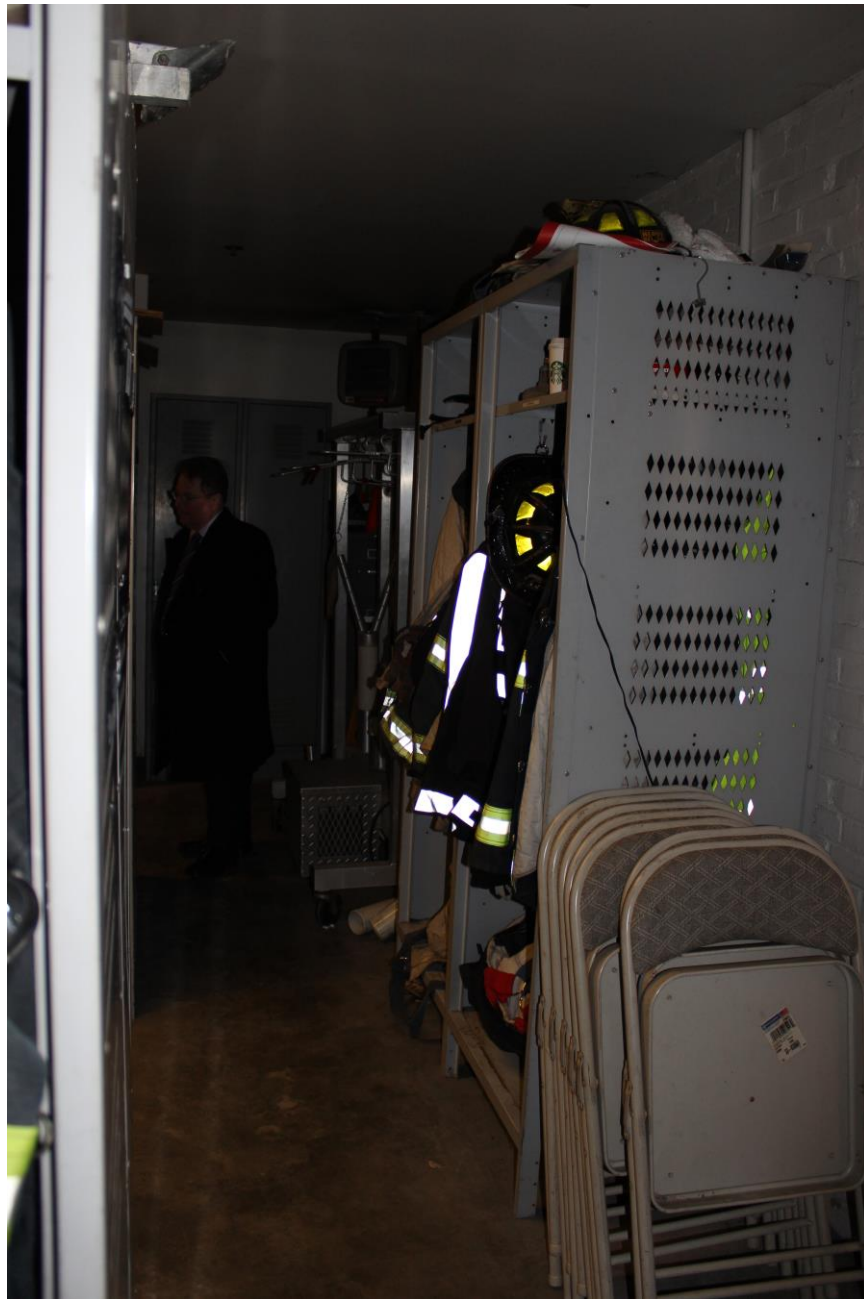
Figure 15 – Existing non ventilated gear room

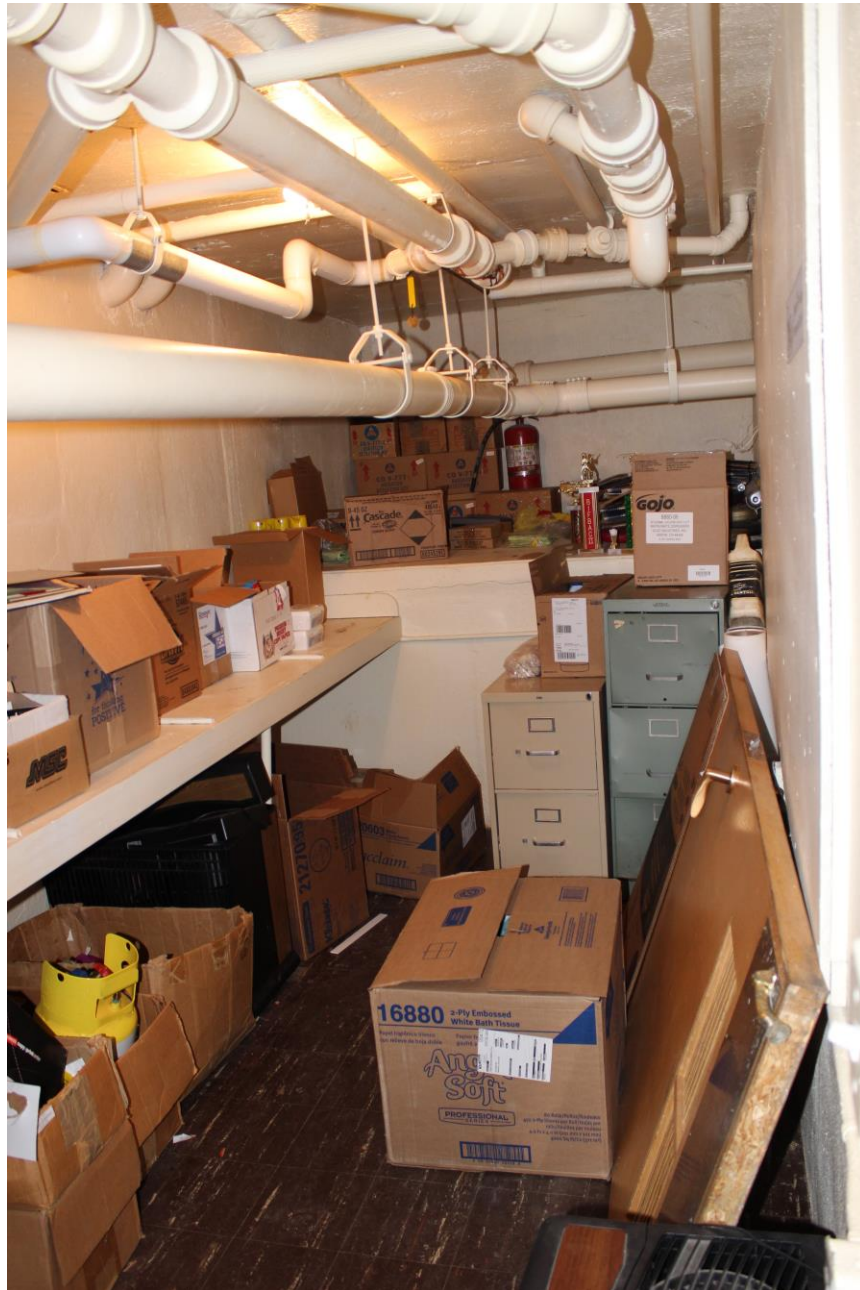
5. The flooring tiles within the basement storage room and A/C room in the attic above the apparatus bay are suspect as being asbestos tiles. A comprehensive evaluation of all the interior finishes should be performed to identify hazardous materials such as asbestos, lead paint, PCB's and the possibility of mercury ballasts within the light fixtures.
6. There are numerous indicators of water stained ceiling tiles, these may be from old roof leaks
7. The flooring in the Administrative office vestibule has been removed and needs to be replaced

Figure 23 – Basement storage room (Suspect ACTM floor tiles)

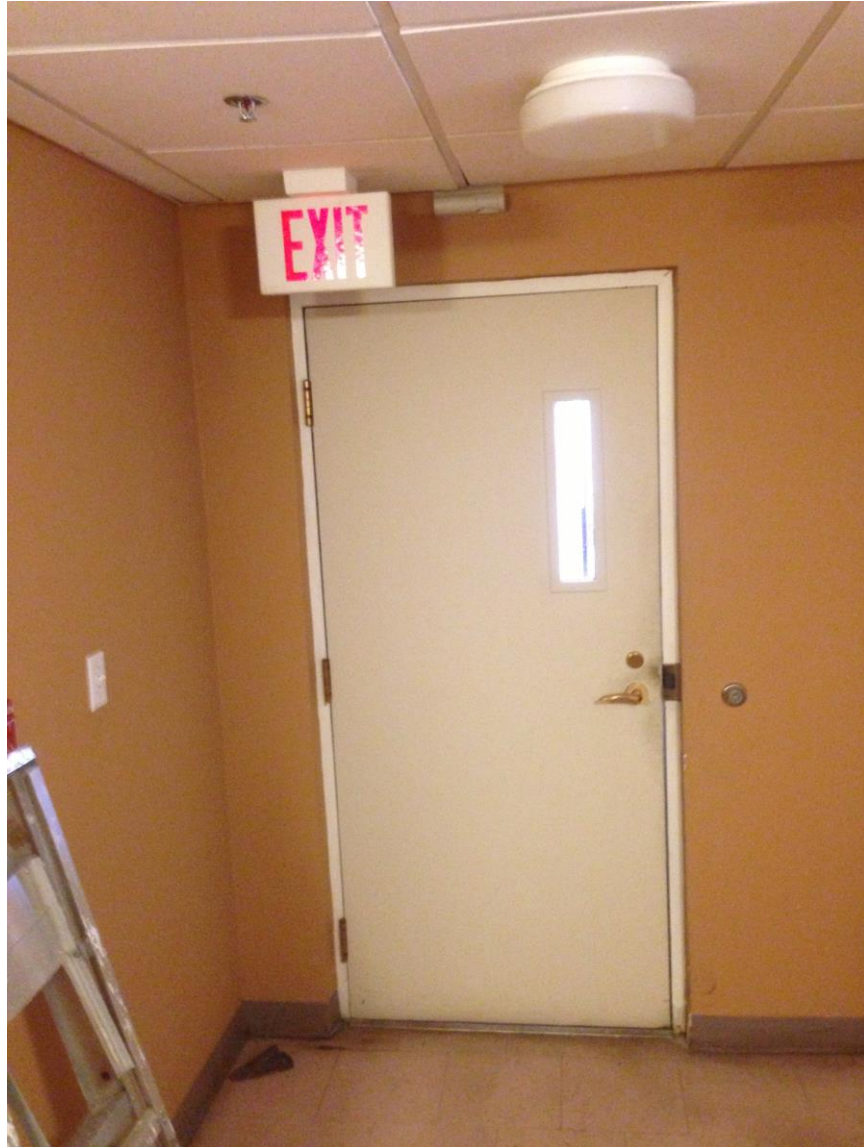
- i. Exit signs are missing, mounted too high or not located properly.
- ii. Exit signs lead staff into the apparatus bay. The apparatus bay is classified as a higher use group and consequently cannot be used as a means of egress.

Figure 28 – Non code compliant egress from the administrative area into the apparatus bay

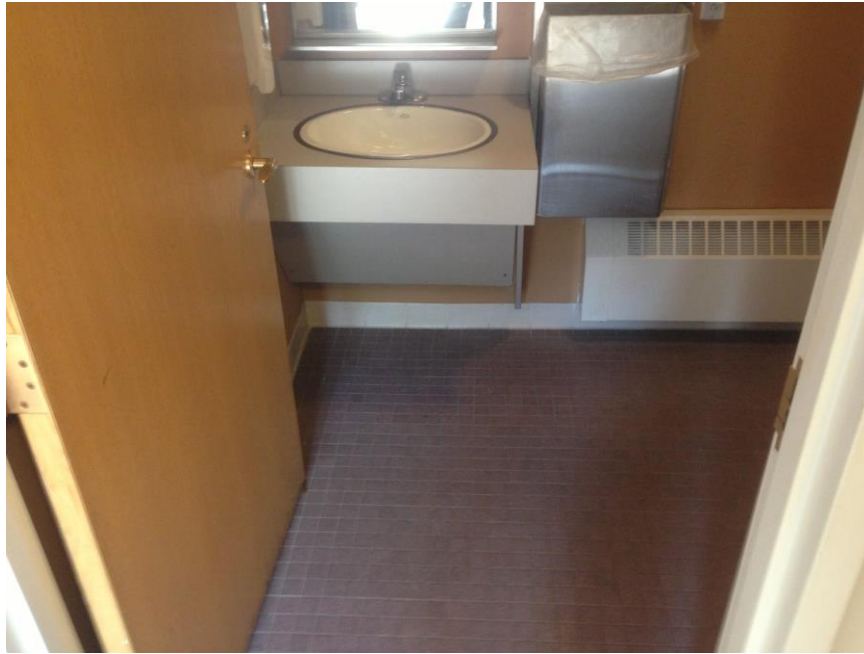
Figure 29 – Non code compliant toilet room in public lobby

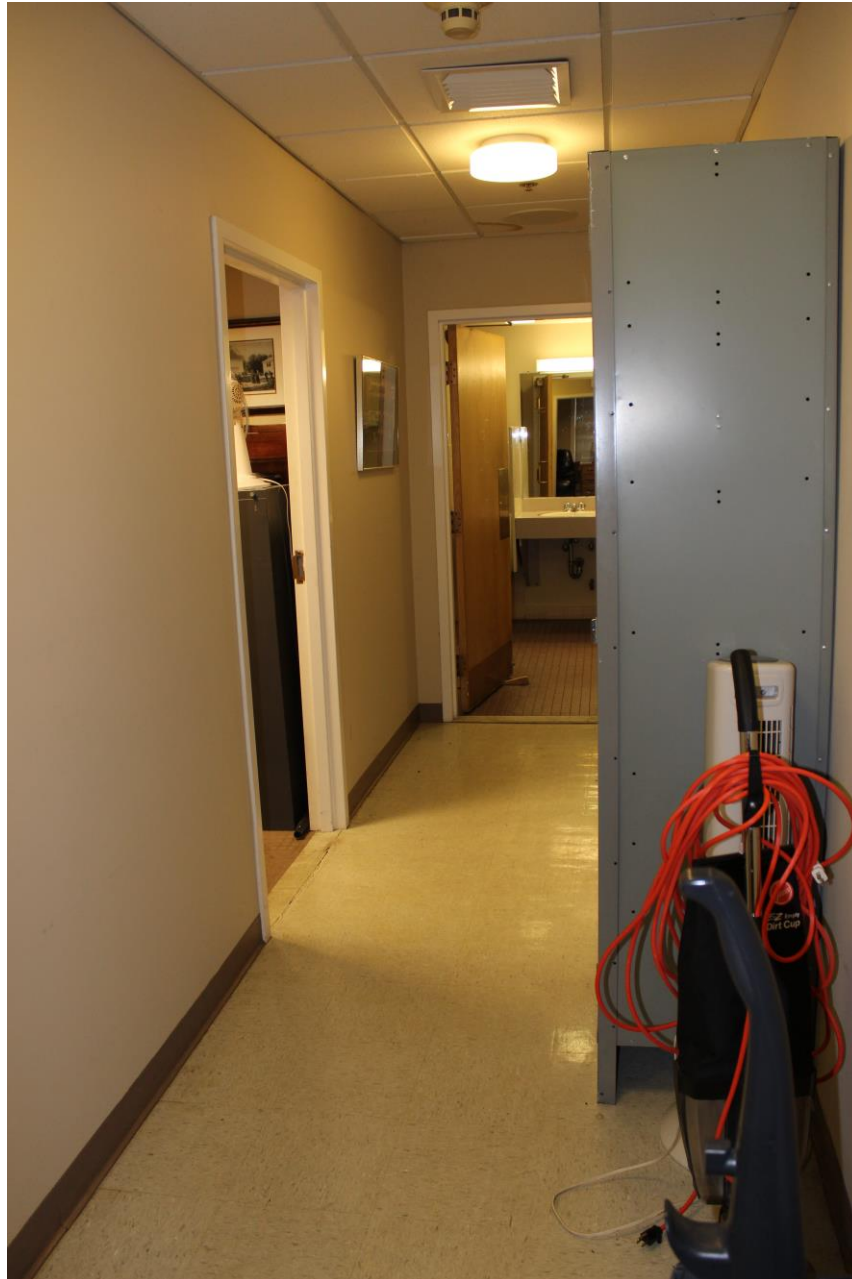
Figure 36 – Existing corridor width minimized by firefighters lockers

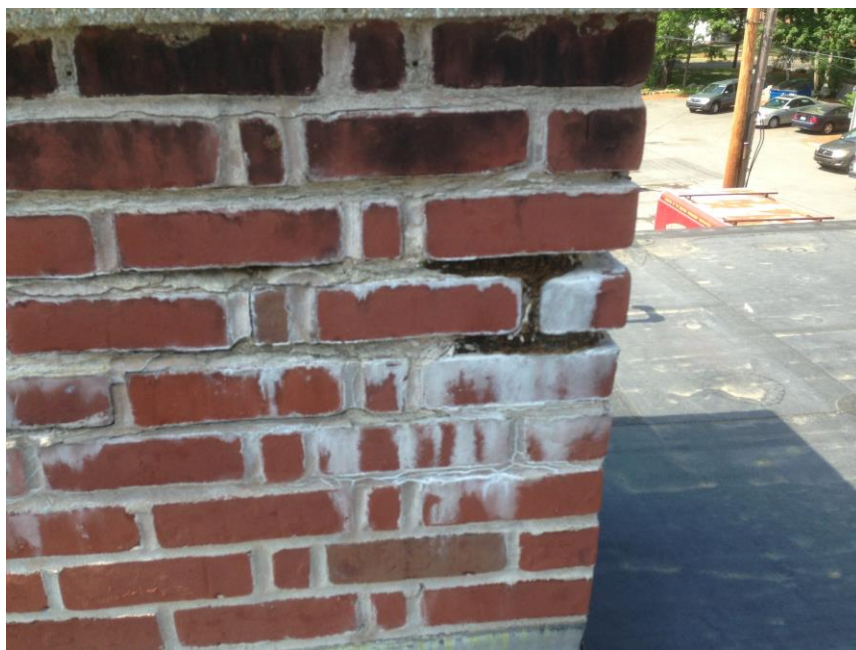
Figure 40 – Existing deteriorated mortar joints in chimney

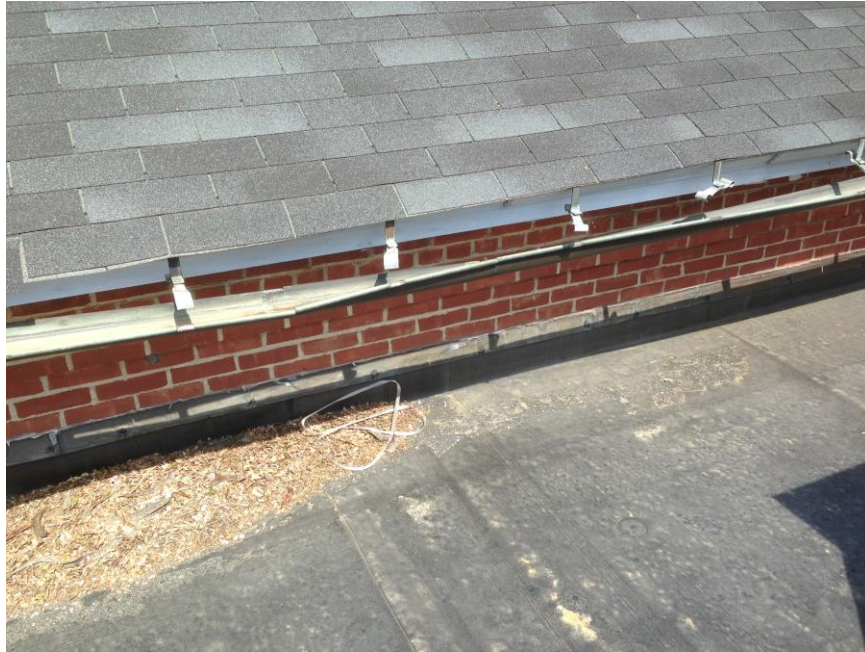
- a. The existing copper gutters need to be straightened and re-secured. The harsh winter has bent the downspouts and torn them off their mountings.
 - b. Most of the gutters are improperly pitched, allowing water to collect and spill over the gutter rather than flow in to the downspouts.

Figure 41 – Deteriorated copper gutters on roof

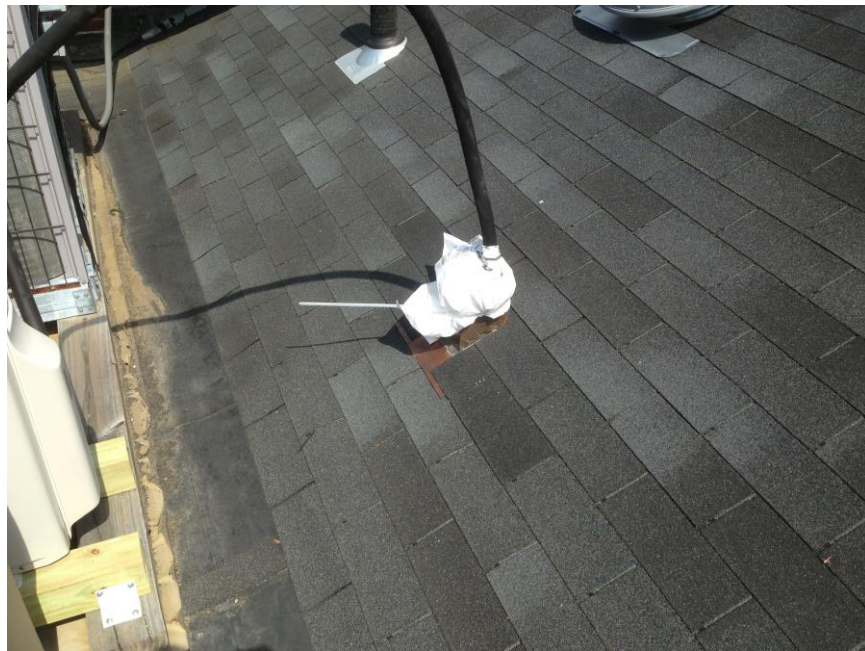
7. Several pipe penetration flashings on the flat roof have been temporarily repaired by what appears to be a plastic wrap. These repairs should be replaced with a more permanent solution.

Figure 42 – Temporary flashing at roof penetration

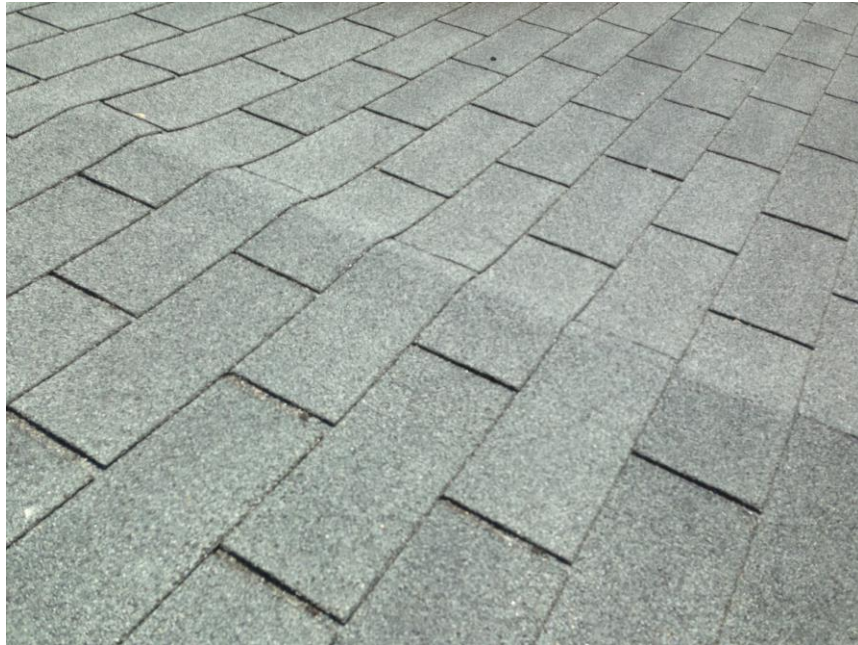
2. There is a visible seam within the sloped roof that appears to be buckling. At the time of the field investigation it was not clear if the seam was located above a previous addition or if the buckling is caused by subsurface structural movement. Further investigation is required to identify the cause of the buckling.

Figure 43 – Buckle in roof telegraphing through the roof shingles

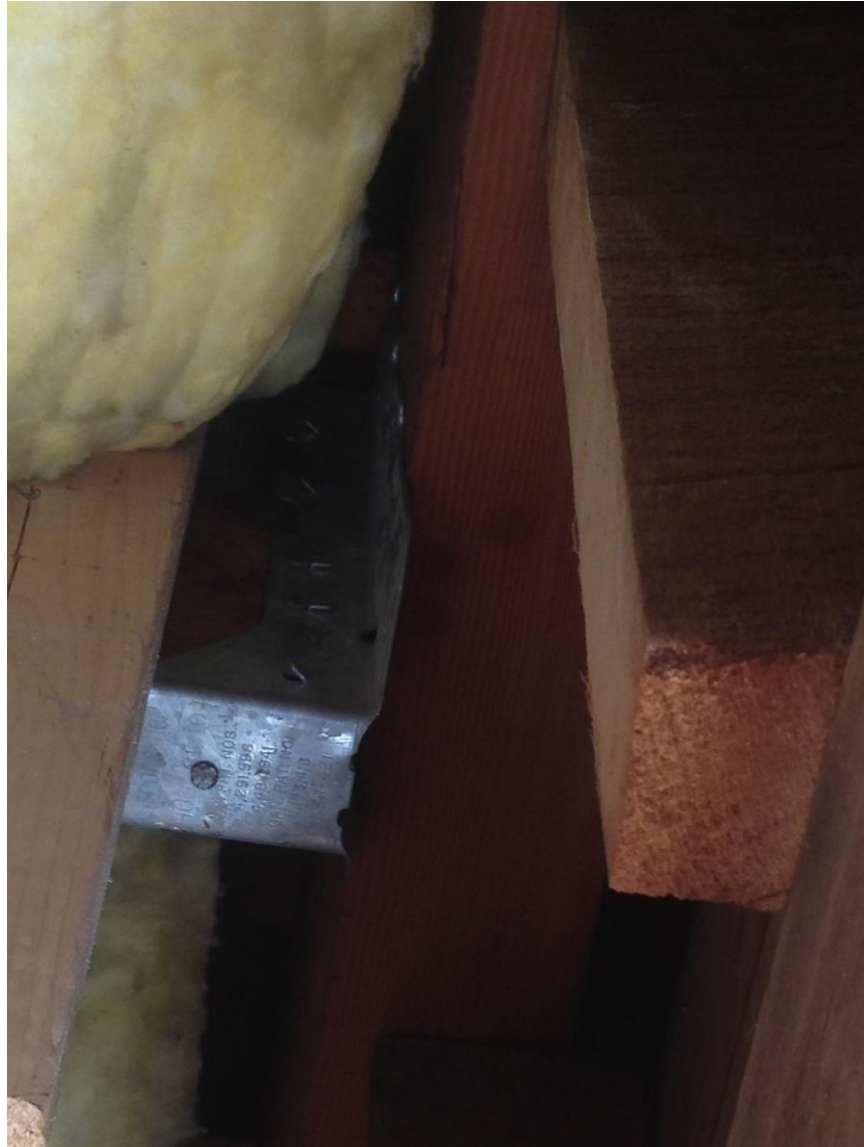
Figure 45 – Improperly attached joist hanger in attic

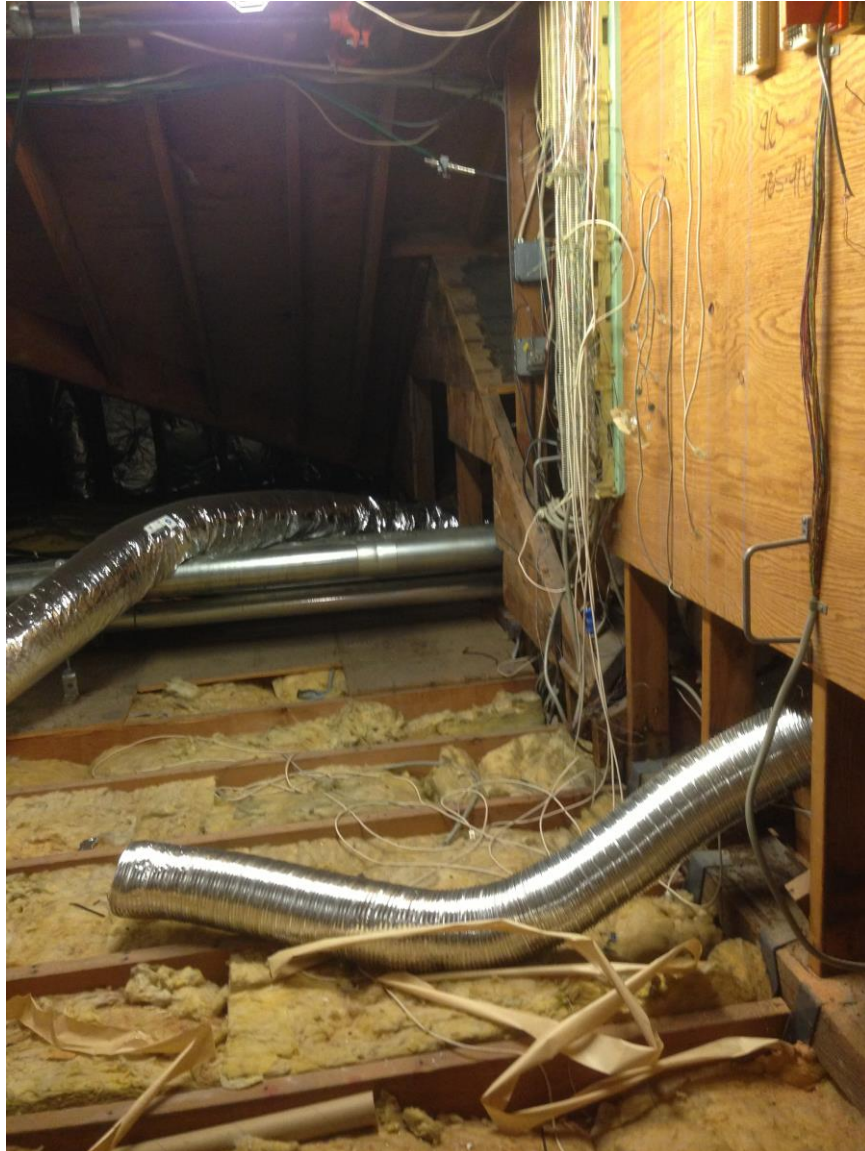
Figure 46 – Duct in attic not attached to diffusers or registers

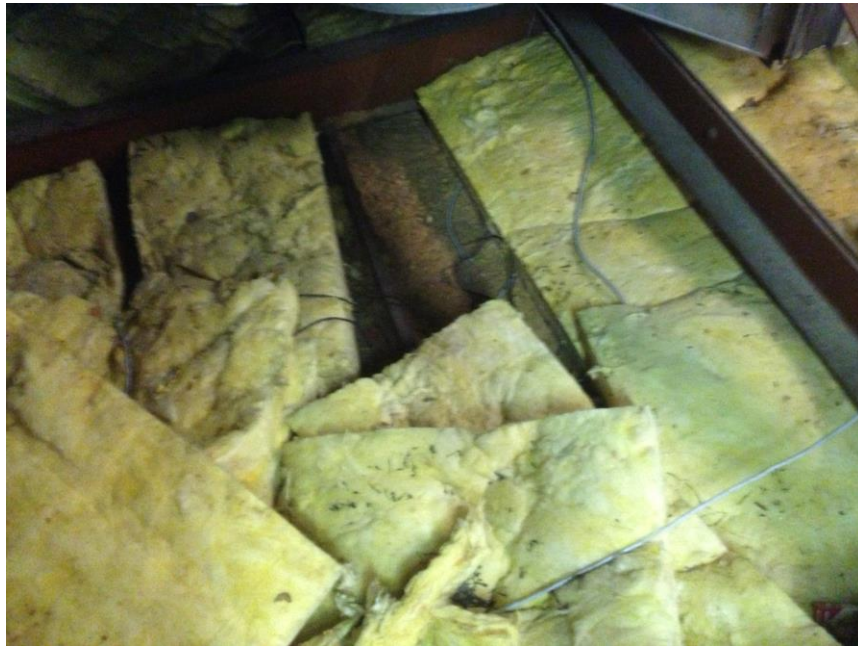
11. Currently some of the attic insulation, within the ceiling joists, has been moved to perform work however it has not replaced in its proper location. Not only is this a major cause of heat loss, but heat in the attic is the primary cause of ice dams.

Figure 47 – Displaced attic insulation

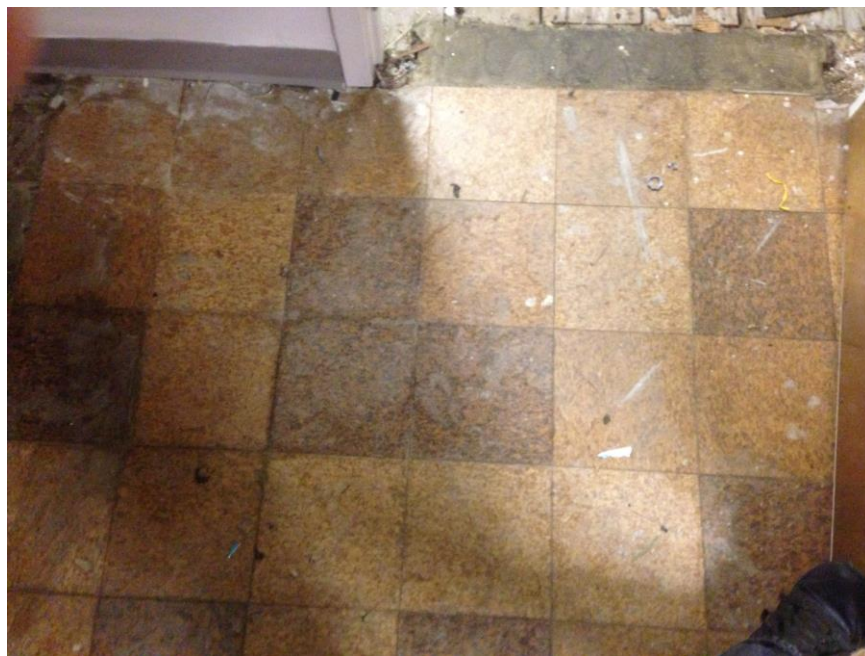
Figure 48 – Suspect ACM floor tiles in attic

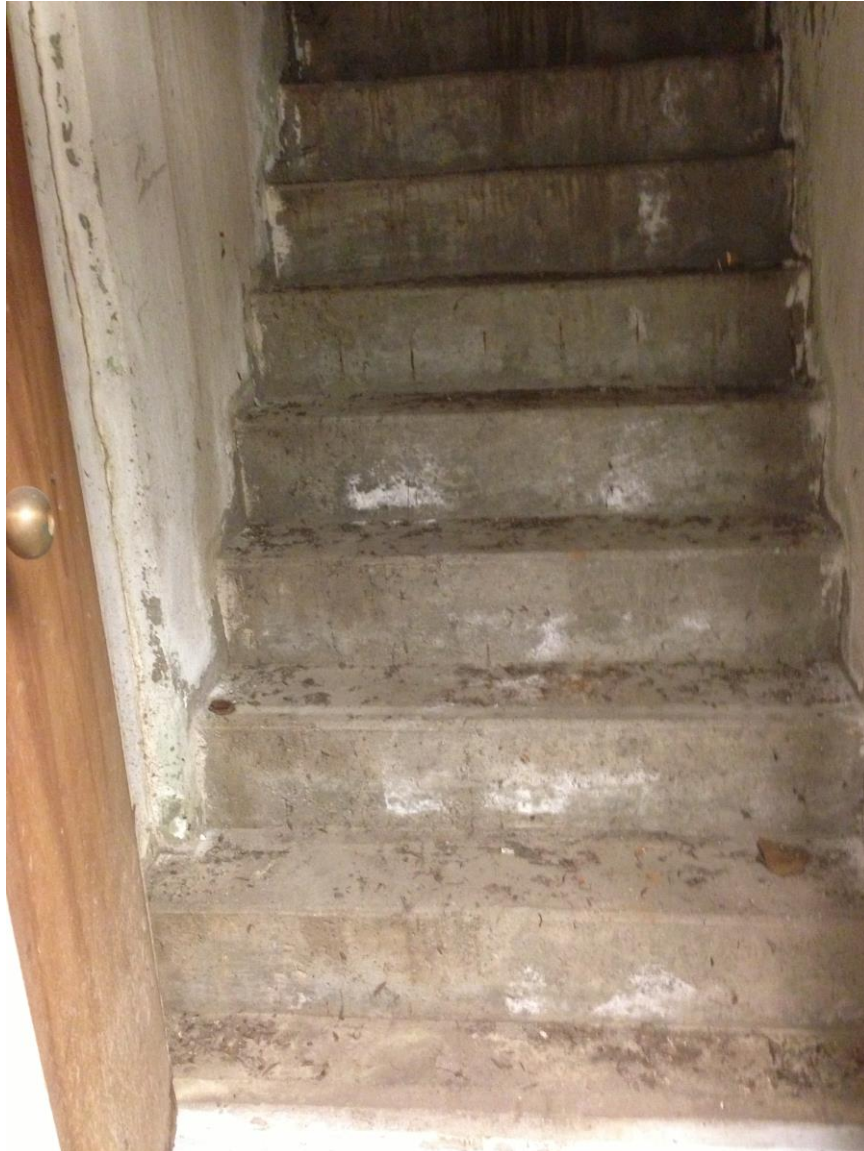
Figure 49 – Non code conforming concrete steps leading out from basement fitness room through bullhead

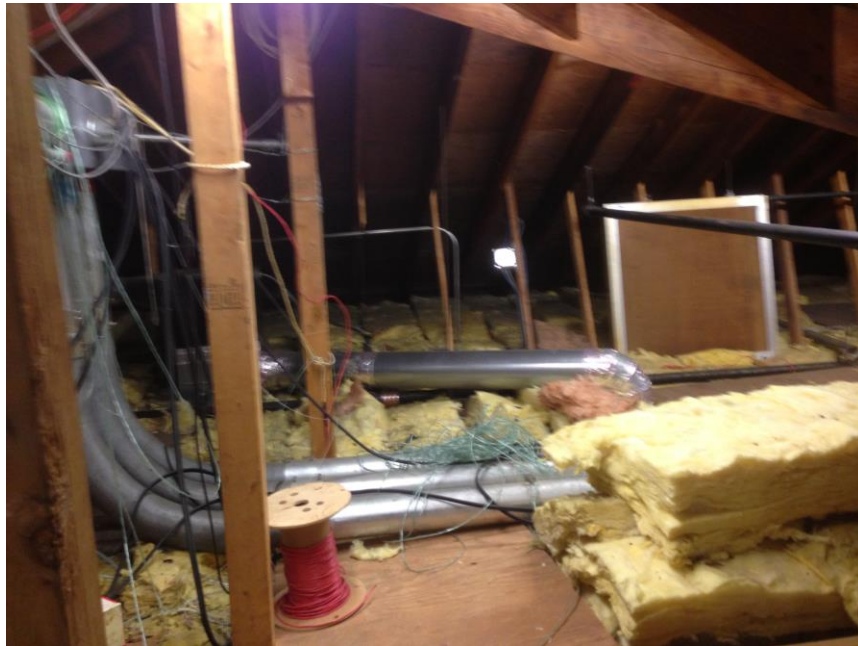
Figure 50 – Misplaced attic insulation

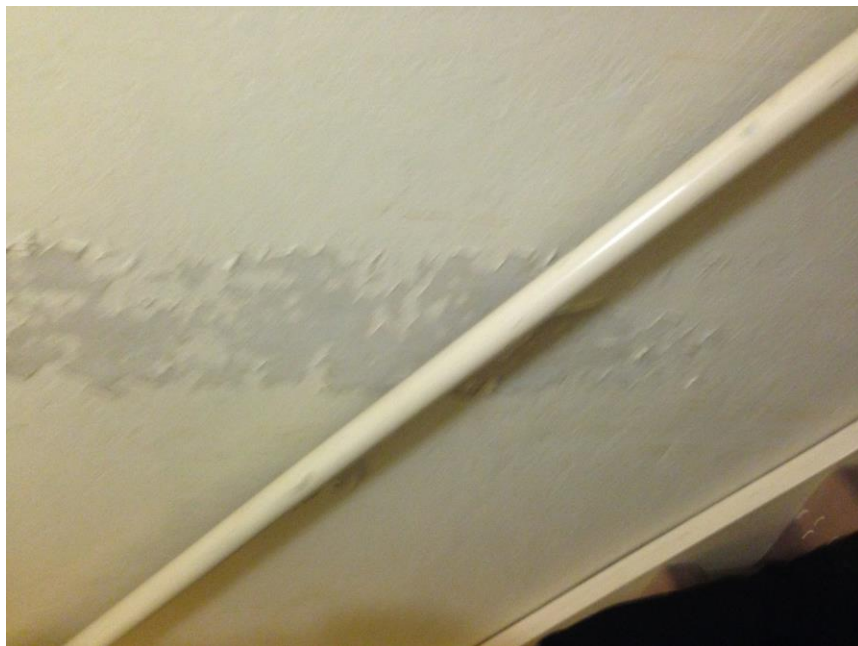
10. The interior of the concrete foundation walls are painted concrete without any waterproofing or vapor barriers. The lack of a vapor barrier is allowing moisture to wick through the foundation wall into the finished spaces. The dampness in the walls is causing the wall paint to peel and also leaving a residual musty smell.

Figure 51 – Flaking paint in basement walls do to moisture infiltration
